REPORT DEFINITIONS & SCOPE

Inspection Report Exclusively For: 1948 Cottage-2016PW

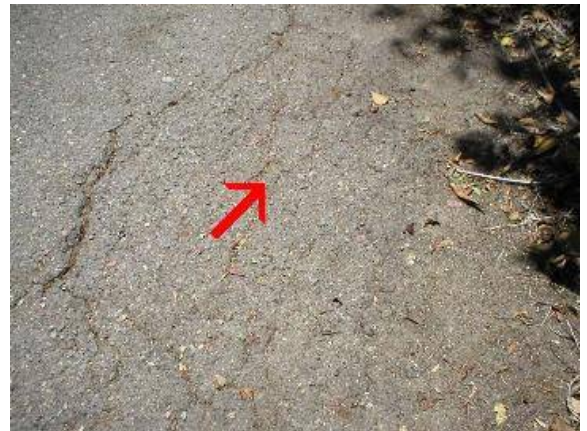
217 DRIVEWAY(S)

[CR] The asphalt driveway is weathered and deteriorated. Continued use without repairs may require replacement.

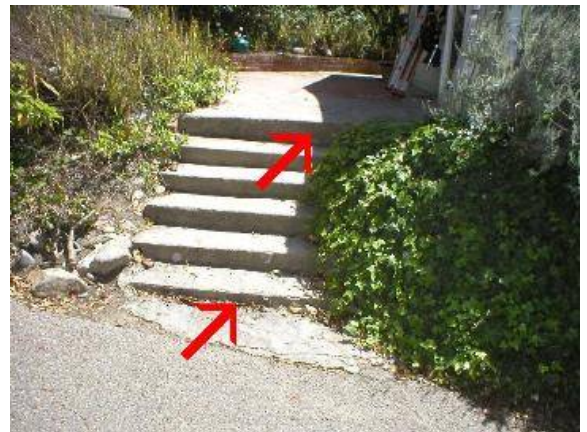
220 STEP(S)/STAIR(S)

[SC] There is improper/inconsistent height/rise on the steps. This condition is a trip hazard.

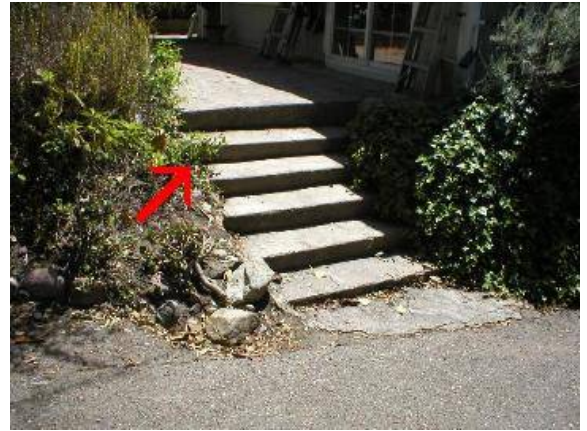
222 HANDRAIL(S)

[SC] There are no handrails at the steps, required when 4 or more steps.

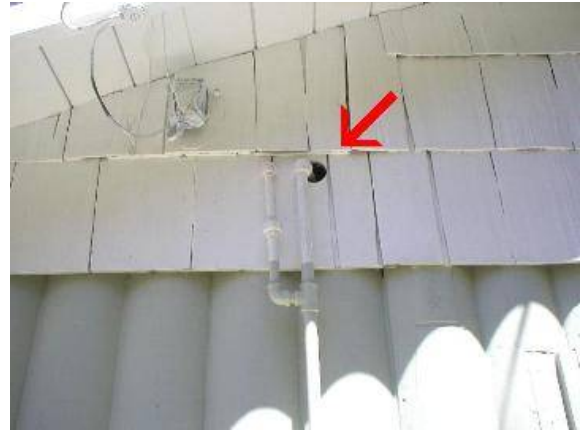
240 SHINGLE SIDING

[CR] There are holes in the shingled siding. These conditions are conducive to moisture intrusion and deterioration.

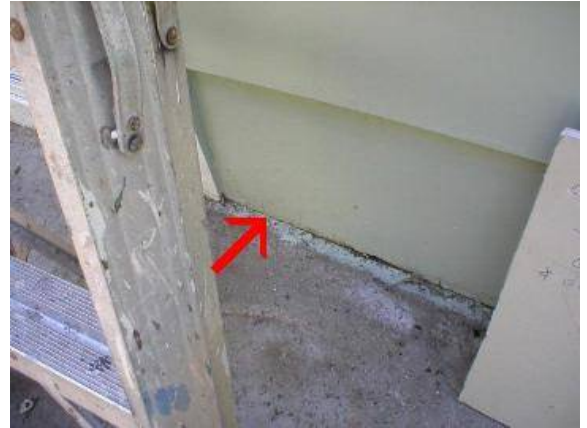
- 241 MANUFACTURED SIDING** [FE] Portions of the manufactured siding lacked adequate clearance from or are buried in the ground. These conditions are conducive to moisture intrusion and deterioration.

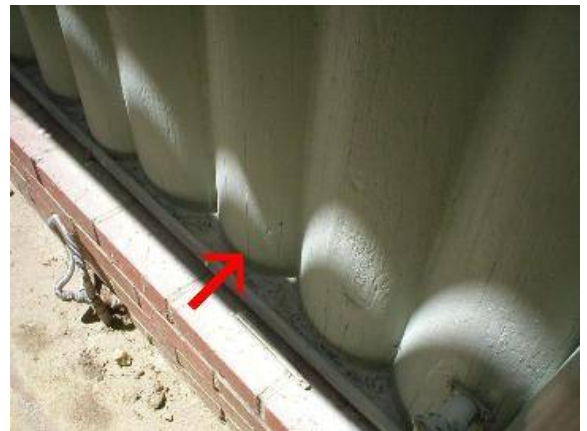
246 VENEER

[CR] There is no observable flashing along the top edge of the masonry walls to the exterior siding connection. The flashing diverts moisture accumulated on the siding out over the face of the veneer, rather than allowing it to get behind the veneer where it may cause damage.

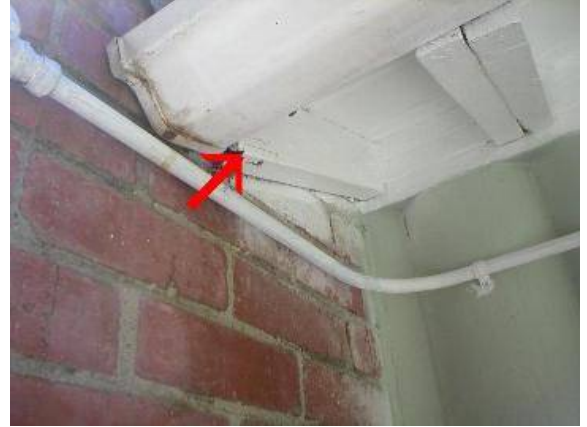
- 247 FLASHING(S) [FE] There are no observable flashings at over the windows, doors and projections of the buildings.
- 248 EXTERIOR TRIM The observable exterior trim materials appeared functional.
[CR] Wood post at the rear with no apparent purpose is damaged.
- 249 EAVE(S)/SOFFIT(S) [CR] There are damaged/deteriorated eave and soffit materials noted.

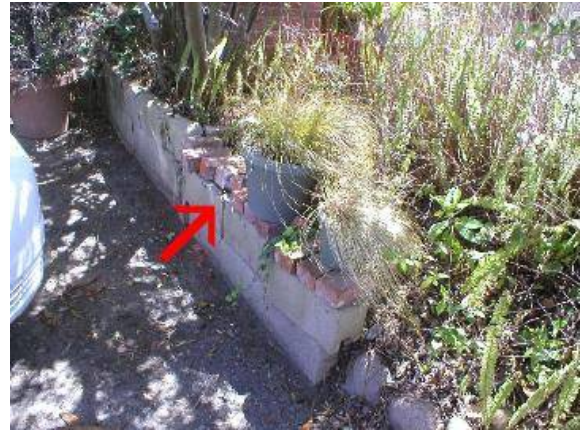
[CR] The decorative retaining/planter walls are damaged. Pic.

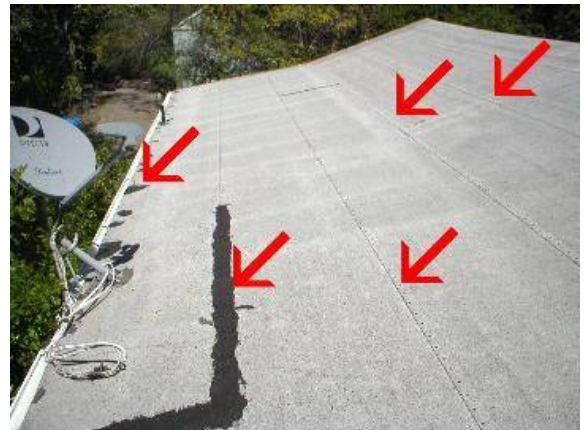
- 314 BUILT-UP ROOFING** [CR] The rolled roofing is a substandard roof installation not limited to face nailing at all connections. Recent patching due to leaks. Ridging of the material etc. The roof is worn and needs replacing.

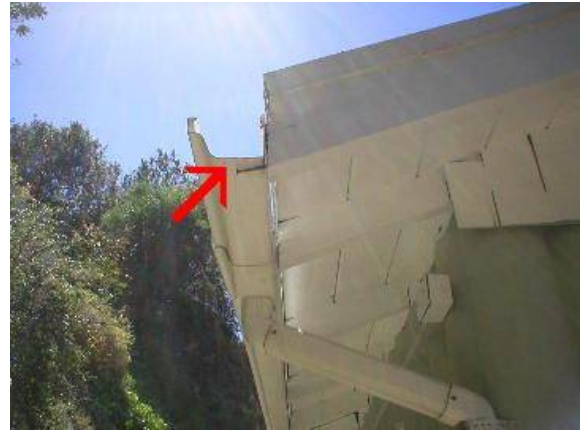
317 ROOF DRAINAGE

[CR] The rain gutters are installed too low to the roof's edge. The connections are poor. End stops are missing. This condition allows water to wash over the gutters rendering them inoperative. The gutters need replacing with metal gutters.

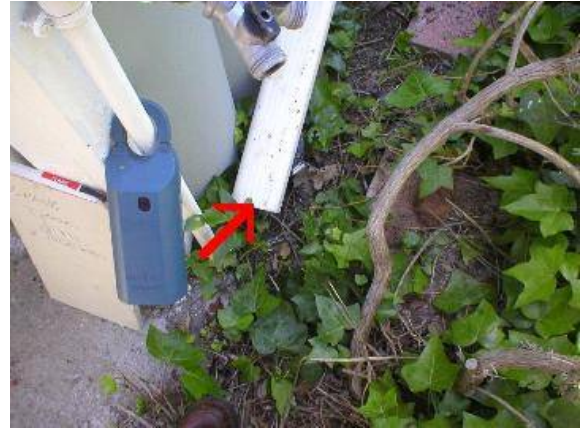
**318 DOWNSPOUT(S)**

[CR] The downspouts are damaged and are missing sections. The downspouts are incomplete, not fastened together. The downspouts dump at the building foundation etc. The downspouts need replacing with metal downspouts and routed into the drainage system.

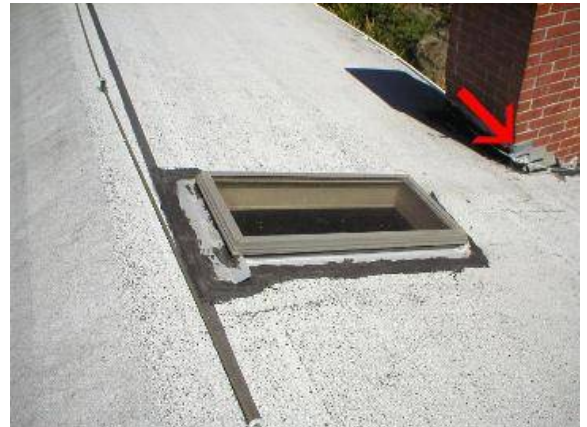
**FLASHINGS****320 FLASHING(S)**

[CR] There are substandard, damaged or missing flashings at the roof penetrations and chimney. The flashings are not installed under the roofing materials. The flashings need to be replaced.

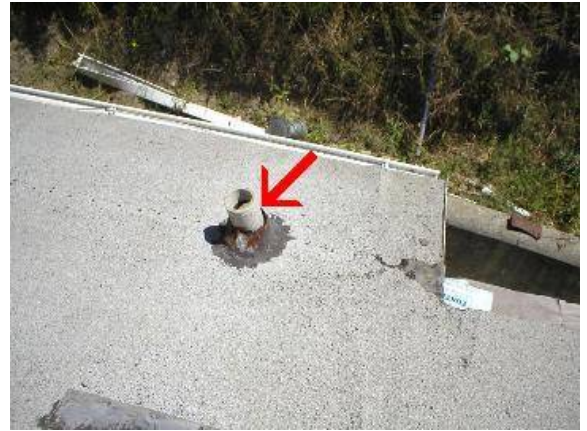
323 FLUE PIPE(S)

[CR] The water heater is missing the flue pipe cap, see # 533.

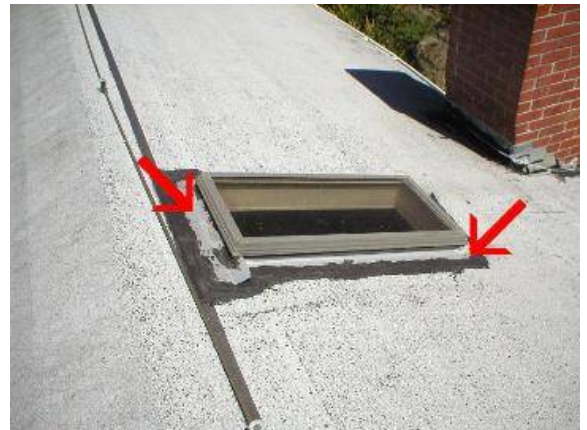
SKYLIGHTS**325 SKYLIGHT(S)**

[CR] The skylight is installed in a substandard manner and has patched flashings.

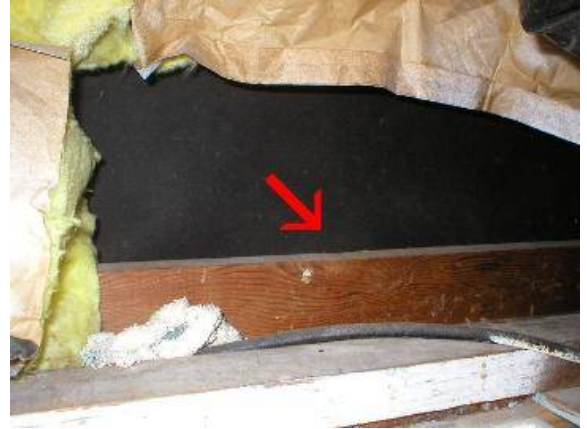
418 INSULATION

[CR] The insulation is out of place/missing in areas. The insulation is not installed on the attic access door. This condition minimizes the overall value of the insulation.

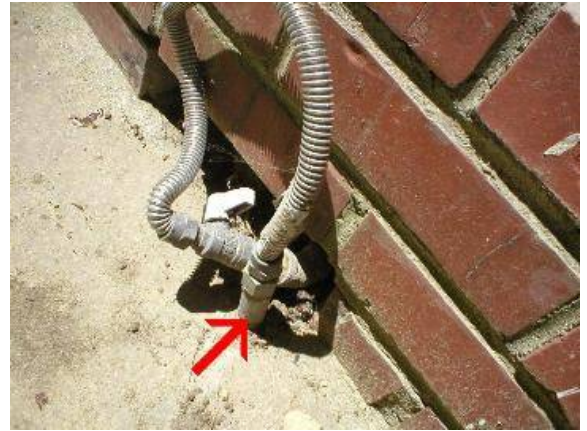
[CR] Areas of the observable gas piping lacked adequate corrosion protection. Left side walkway.

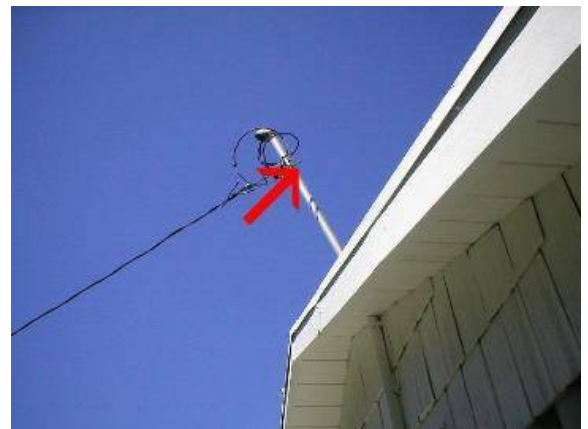
- 607 SERVICE WIRING [SC] The overhead electrical mast lacked adequate bracing and is leaning.
- [CR] Tree branches are in contact with the overhead service entrance cables.

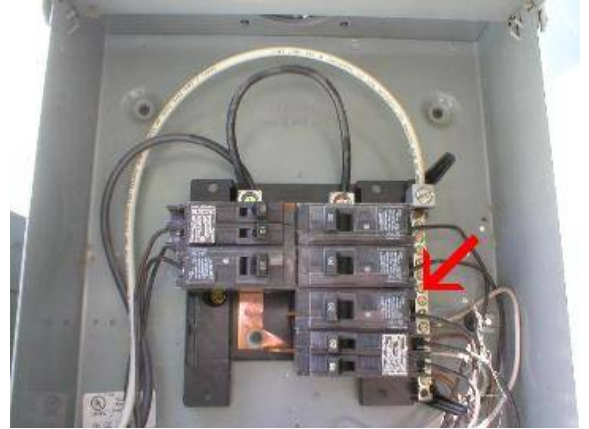
611 GROUNDING **[SC]** The grounding is compromised due to plastic piping present in the plumbing system. A minimum of two grounding methods has been required for over 50 years. Recommend to correct.

[CR] Neutrals and grounds are mixed.

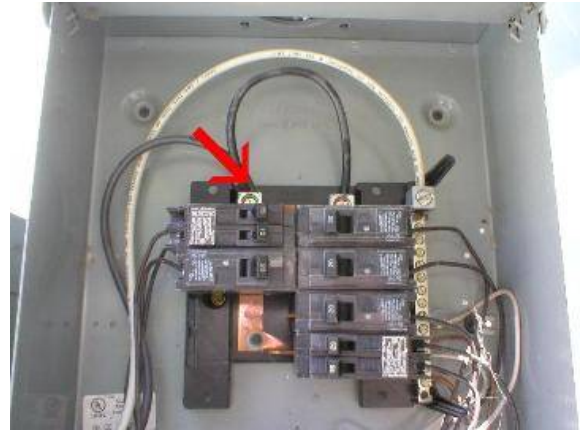
619 WORKMANSHIP

[SC] Double taps noted in the panel.

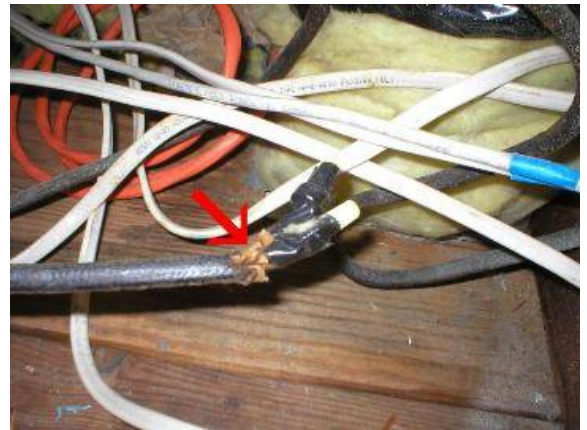
[SC] The exposed wiring within six feet of the attic access opening is not protected from damage and is damaged

[SC] There are electrical wiring connections that are not contained in approved electrical junction boxes at the following locations: attic.

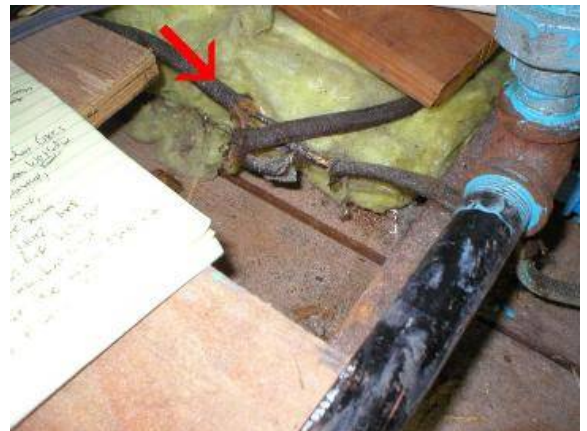
623 COMMENTS

[SC] Improper damaged live wiring with exposed splices is noted in the following locations: attic

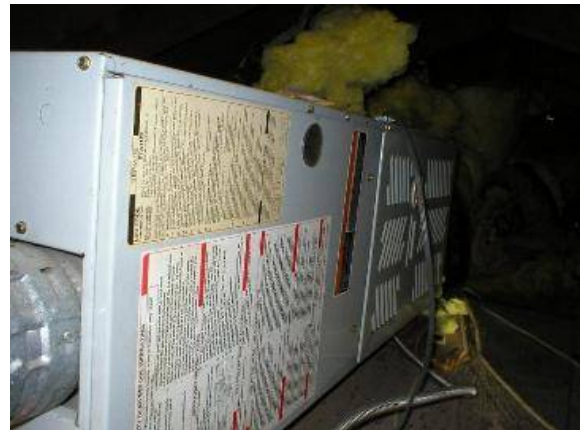
701 LOCATION(S) The unit is located in the attic.

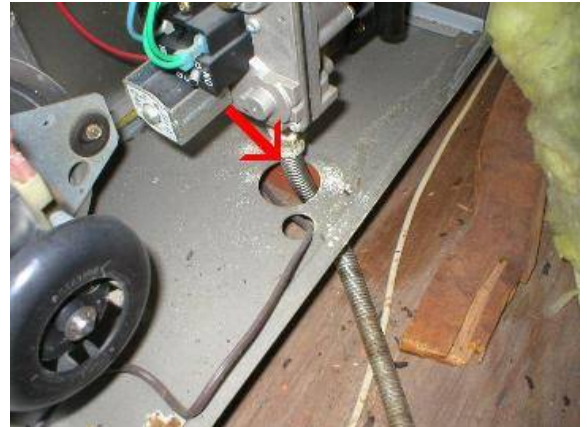
727 HEATING EQUIPMENT ENERGY SOURCE CONNECTIONS	The gas shutoff valve appeared functional, The electrical power cord connections appeared functional [SC] The gas line is not hard piped to the exterior of the furnace housing. [SC] There is no sediment trap/drip leg in the gas line as required by the manufacturers installation instructions. Traps are designed to collect debris such as rust and swarf etc. Debris causes improper burning of the gas. This creates carbon monoxide.
---	--

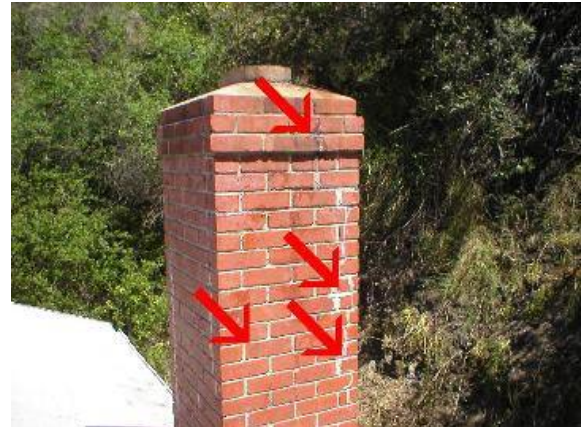
- 805 CHIMNEY(S) [FE] [SC] The chimney is crack damaged. Cracked masonry chimneys in seismic zones are considered a hazard needing correction
- [CR] There is no observable flashing between the exterior siding and the chimney. The flashing is used to prevent moisture intrusion and deterioration where the dissimilar materials meet.

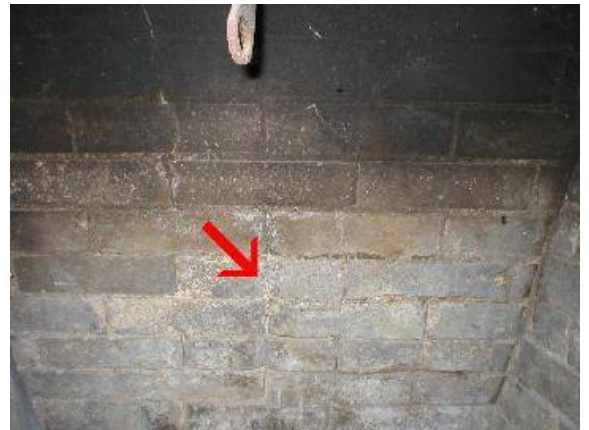
[SC] There are cracks in the fire box walls, the fire box refractory walls need replacing.

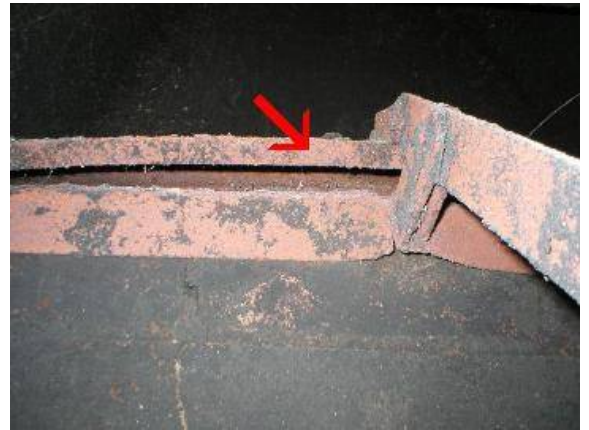
[CR] The flue damper is stuck and damaged.

[SC] The observable areas of the flue are dirty with soot/creosote build up. This condition is a fire hazard. We recommend the flue and related components be cleaned by an appropriate professional in the appropriate trade.

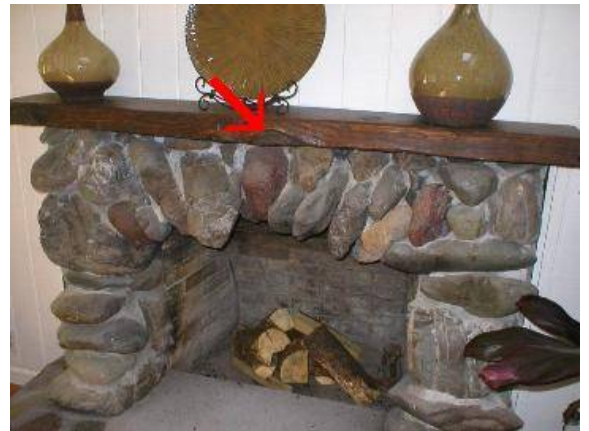
810 ACCESSORY(S)

[SC] The wood mantle is too close to the fireplace opening. This condition is a fire hazard when burning wood.
