REPORT DEFINITIONS & SCOPE

Inspection Report Exclusively For: Commercial-20K-2016PW

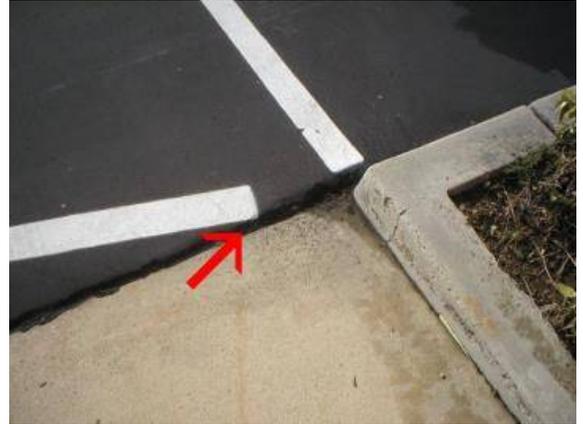
217 DRIVEWAY(S) **[SC]** Uneven sections in the driveway surface. This condition is a trip hazard. Warehouse door at the concrete to asphalt transition

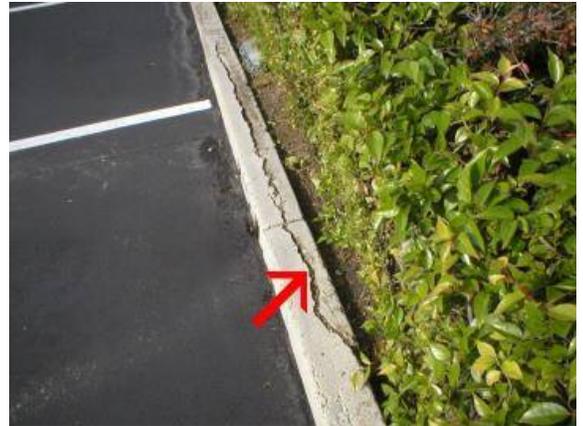
[CR] Due to over watering of the sprinklers the concrete curbs at the rear have split.

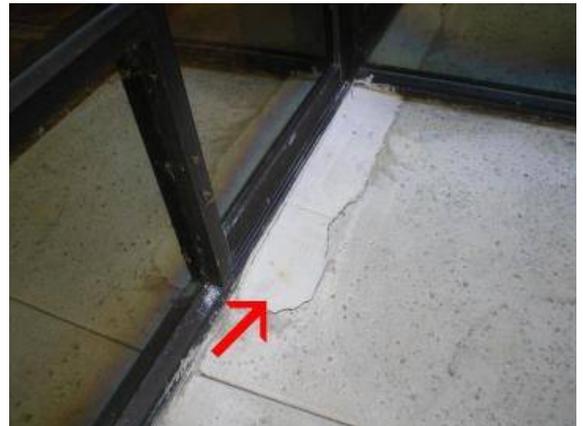
[CR] Improper concrete walkway ramps noted at the atrium are breaking up.

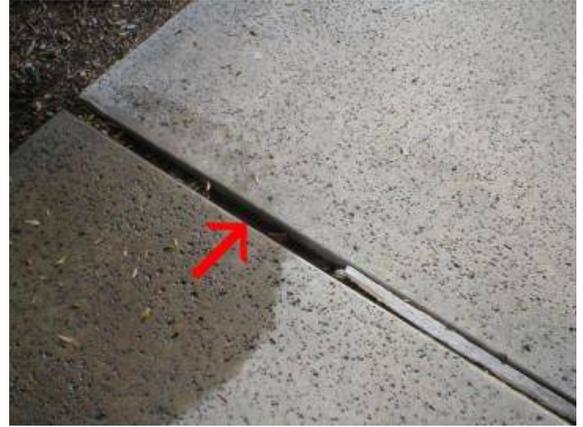
[SC] Sections of the expansion-joint materials are damaged, deteriorated & missing. We recommend correcting any trip hazard conditions. Patio and atrium

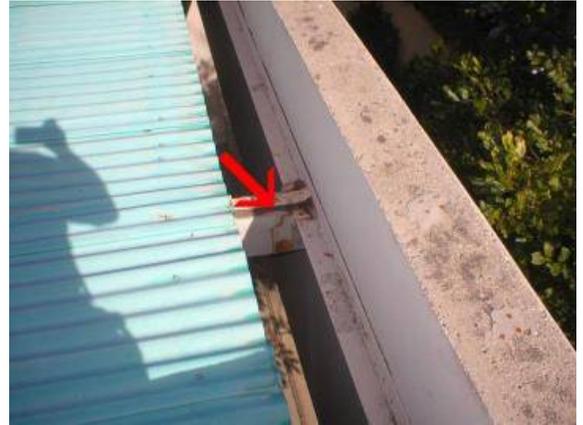
[FE] [CR] Damage/deterioration observed at the patio cover panels and corrosion of the metal support structure noted.

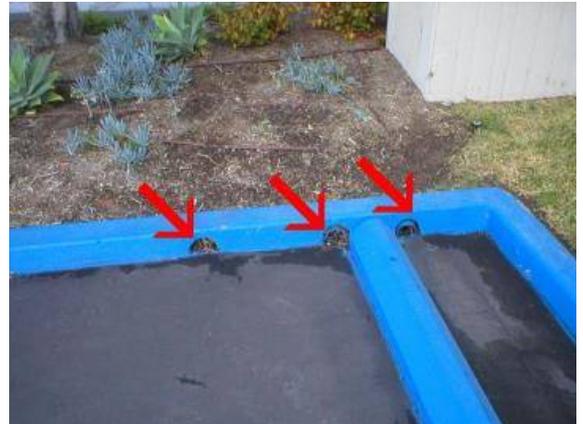
[CR] There are drains in the curbs that are blocked with debris. We recommend all debris be removed and all drains should be cleaned on a regular basis.

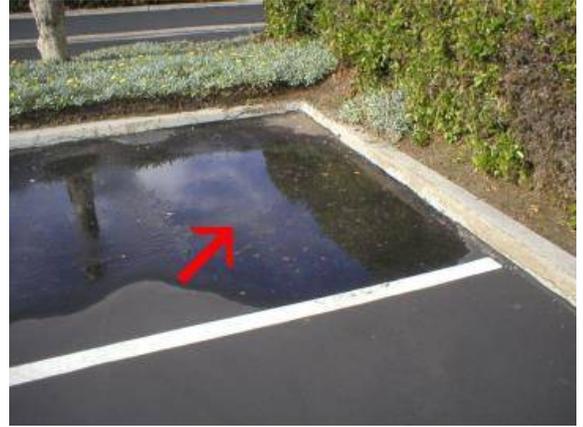
[SC] Ponding water on the parking areas. This condition is a slip and fall hazard.

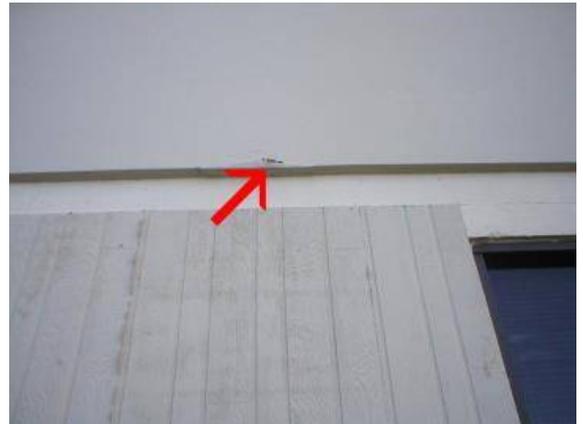
- 238 STUCCO CLADDING [CR] The stucco siding has moisture damage & deterioration at the right front of the building.

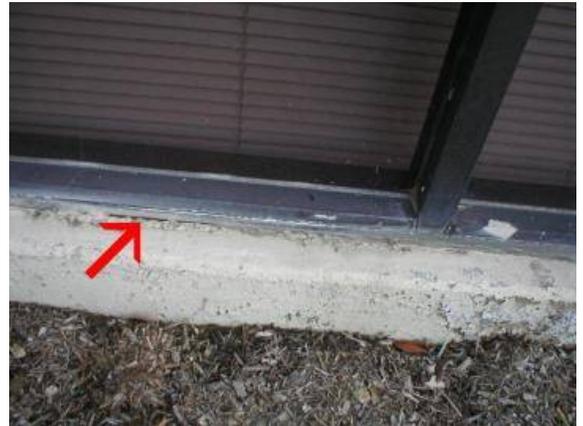
- 253 DOOR(S) The doors viewed from the exterior appeared functional, with signs of aging and wear.
- 254 WINDOW(S) The windows viewed from the exterior appeared functional, with signs of aging and wear
- [CR] The base of the windows have gaps noted allowing moisture to intrude, all windows need to be sealed.

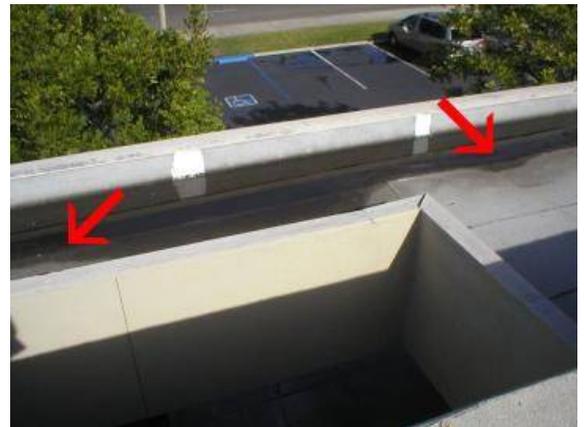
- 314 BUILT-UP ROOFING** [CR] There are areas where an improper configuration or sagging of the roof results in poor drainage and ponding. Over the exterior entry and the main roof.
- The observed areas of the roof appeared functional with signs of weathering and aging. Patch repairs are noted. Periodic inspection and maintenance is recommended.

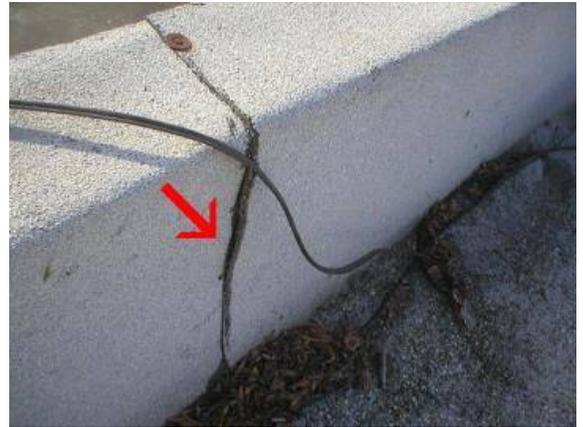
[CR] There are open materials on the parapet walls. This condition is conducive to leakage. Recommend to caulk the cap fasteners

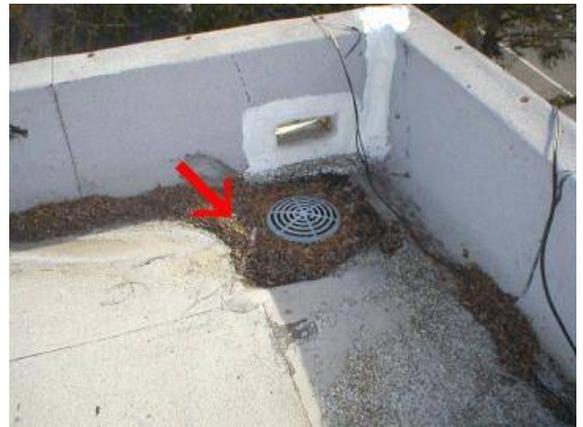
[CR] The drains are filled with debris which restricts proper drainage.

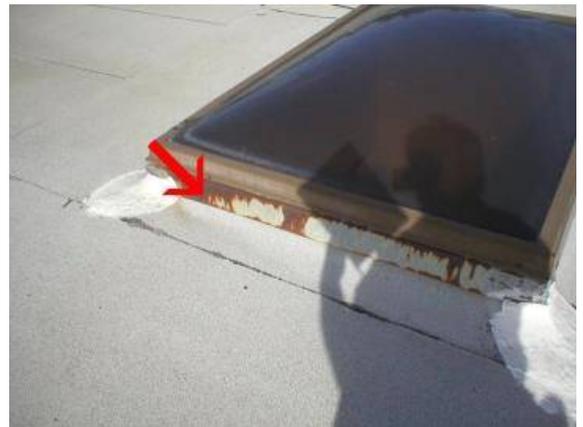
[CR] Some of the flashings are rusty. We recommend they be cleaned, painted and/or replaced as needed.

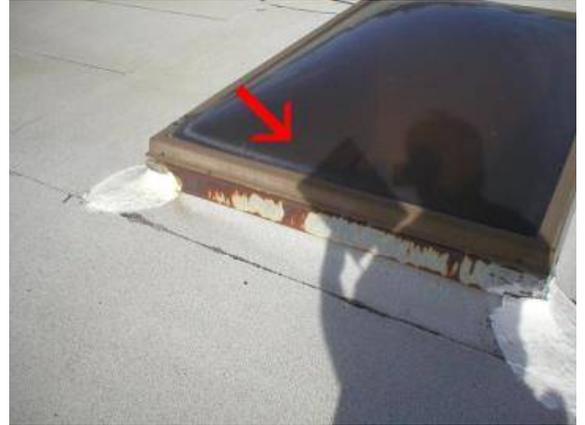
- 326 SKYLIGHT(S) [FE] The observed skylights appeared functional with aging noted. Regular maintenance is recommended.

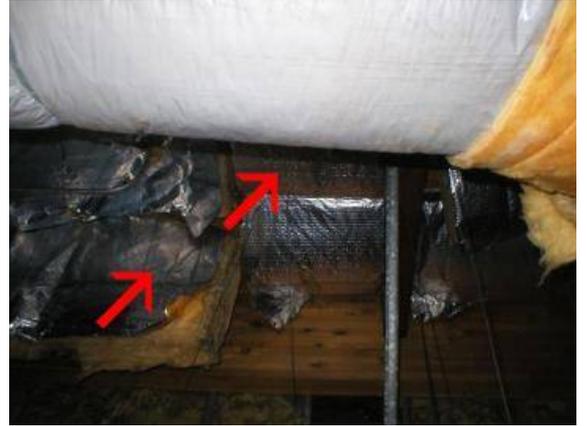
[CR] The insulation is out of place/missing in areas. This condition minimizes the overall value of the insulation.

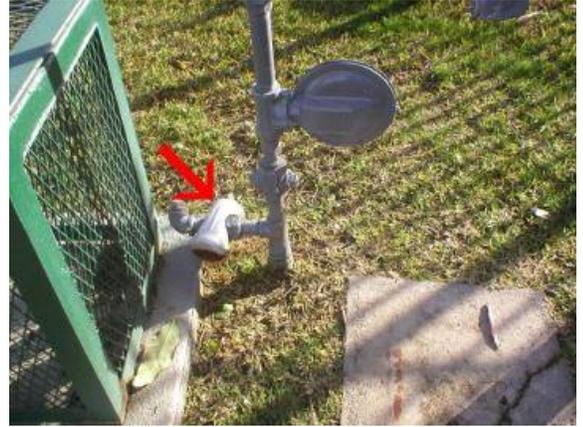
[FE] The gas service was locked "off". We recommend having the Gas Company turn the gas service "on" and check for proper operation and leaks.

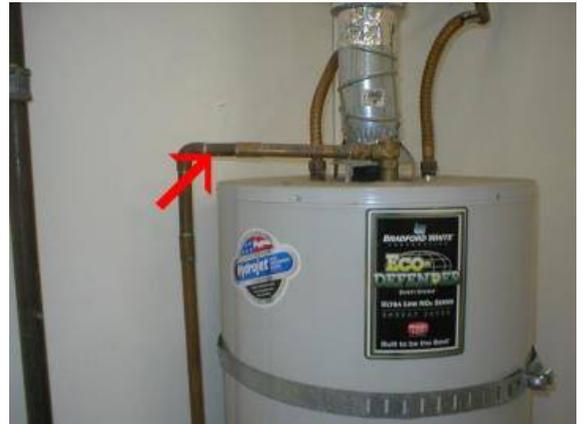
- 533 VENTING SYSTEM(S)** The observed areas of the flue vent piping are intact and secured at the connections.
- 534 SUPPLY PIPING** [CR] The shutoff valve and observed water supply connectors appeared functional, they are not insulated. We recommend insulating the exposed water piping to minimize heat loss.
- 535 "T & P" VALVE(S)** [SC] The temperature & pressure relief valve's discharge line sloped upwards in a manner that will trap water in the line. We recommend installing an approved discharge line that extends to the exterior and terminates close to the ground facing downward.

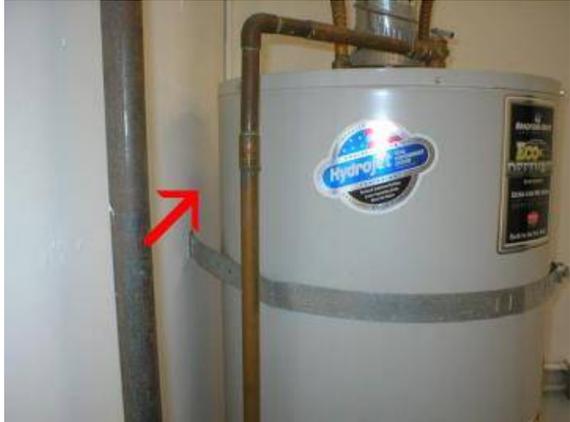
- 536 **TANK(S)** The water heater tank appeared functional. An expansion tank is present and appeared functional.
- 537 **SEISMIC BRACING** [SC] The water heater is double strapped, it is not stabilized/blocked at the rear to resist movement as required.

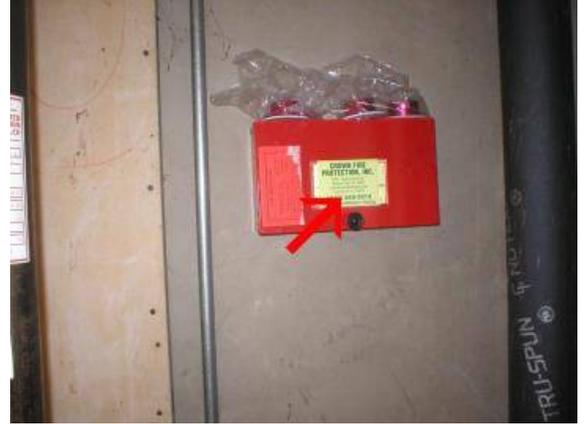
[FE] There are a number of different fire sprinkler heads in use today that are known to be defective. We recommend checking with a qualified fire sprinkler contractor to learn more about the defective makes and models.

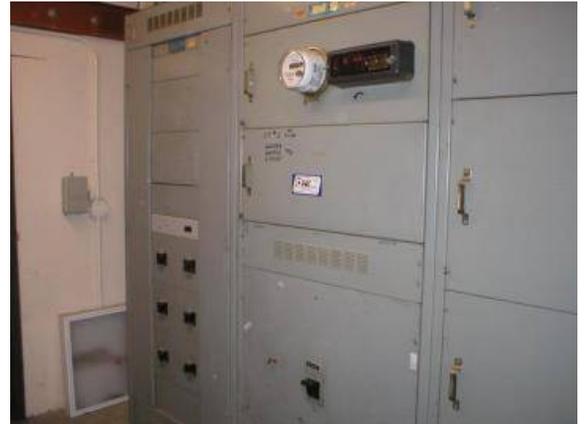
| 602 MAIN PANEL | Located at the left side of the building in a closet off the warehouse. |
| 603 SERVICE RATING | 3 ph, 4 wire, 120/240 volt system, rated at 1600 amperes. |

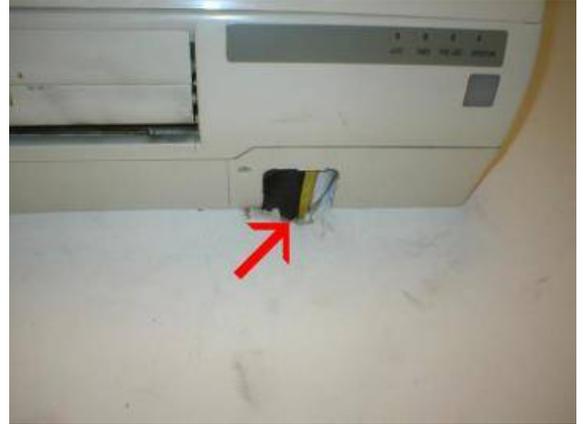
[SC] Improper exposed wiring with inadequate protection was noted in the following locations: Yellow wire at the thru the wall mini split air conditioning in Rm 26.

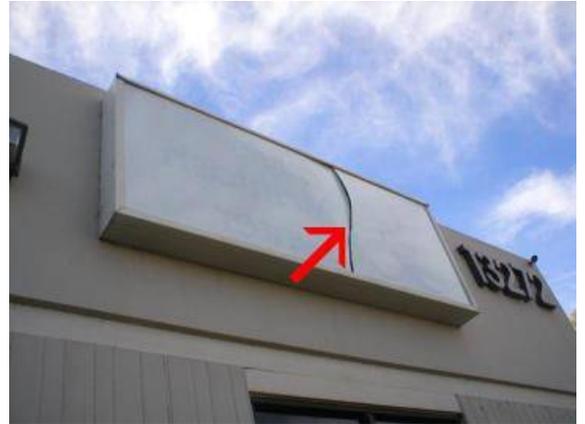
- 627 SWITCHES** The accessible switches are functional with exceptions.
- 629 GROUNDED RECEPTACLE(S)** [SC] There are loose receptacles through out the building, this is a fire hazard
- [CR] [FE] There is no power at a number of the receptacles. Rm 25, outside Rm 27-40. Warehouse.
- [SC] Receptacle cover plates are missing. Electrical Rm
- [SC] Receptacle cover and switch plates are damaged: Several rooms.
- 630 LUMINARIES [LIGHT(S)/FIXTURE(S)]** [CR] Some of the luminaries [light(s)] failed to function. Outside the front entry, janitorial closets, off lunch room, rear hall, exterior rear wall.
- [CR] Luminaire [light] lenses are cracked at: Rm 20.
- 632 GFCI DEVICE(S)** [SC] There is no GFCI protection provided at the areas where required today. We recommend upgrading by providing GFCI protection at the appropriate locations. Bathrooms.
- 634 COMMENTS** [CR] Damaged signage noted.

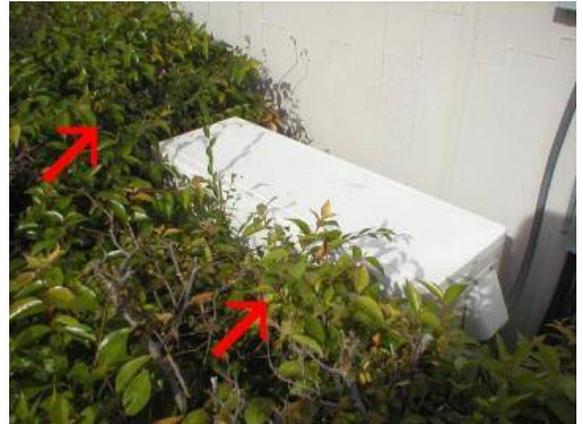
- 723 CONDENSING UNIT(S)** [CR] Vegetation is growing on and around the condensing unit. This condition is conducive to deterioration of the unit and reduces the overall performance.

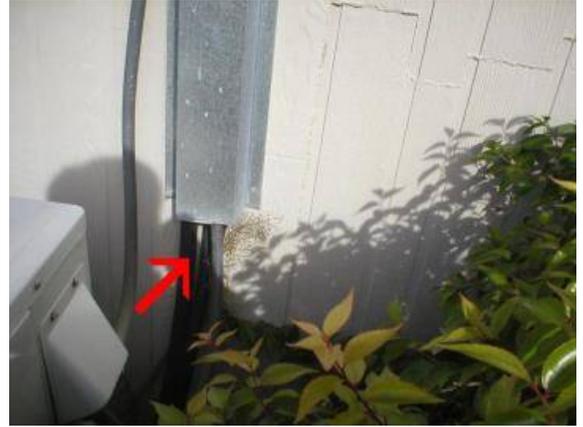
[CR] The coolant lines are not sealed to the wall where they entered the building. This condition allows for rodent access.

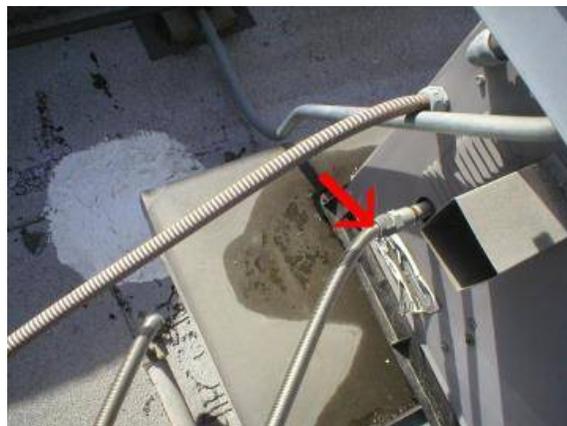
[CR] There are no sediment trap/drip legs in the gas lines as required by the manufacturer

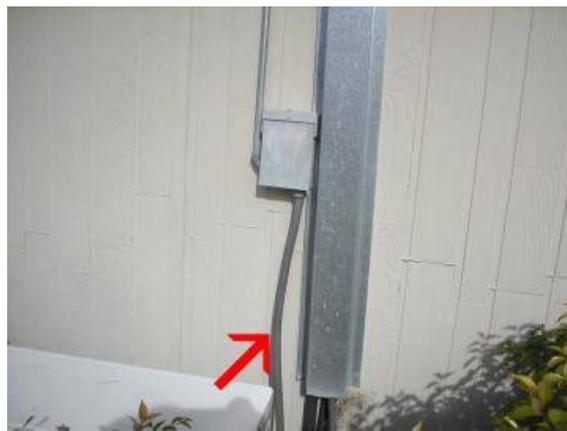
[CR] The flex connector/conduit is not fastened to the wall after exiting the electrical disconnect panel at the exterior of Rm 26. Pic

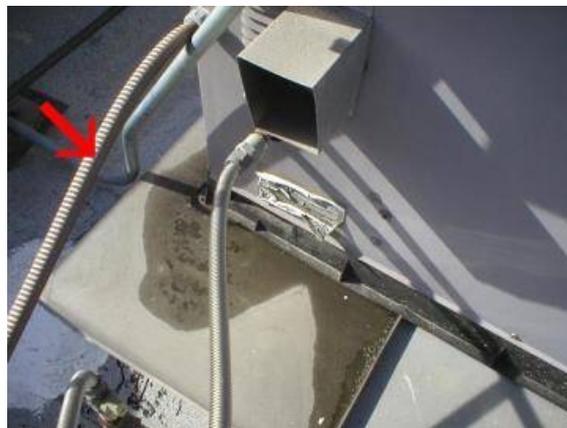
[CR] Most of the electrical whips are sun damaged and need replacing. Roof

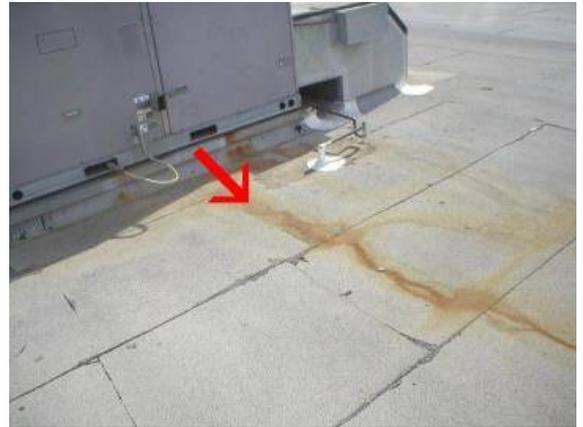
[FE] The condensate drain system shows evidence of leaking. Right rear unit

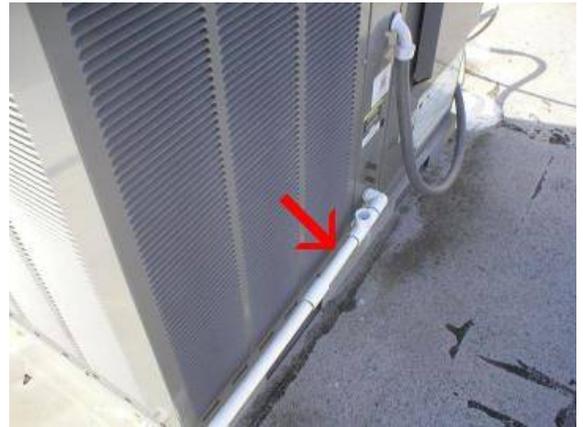
[CR] Several units are missing the traps as required, several have unprotected plastic lines that are sun damaged.

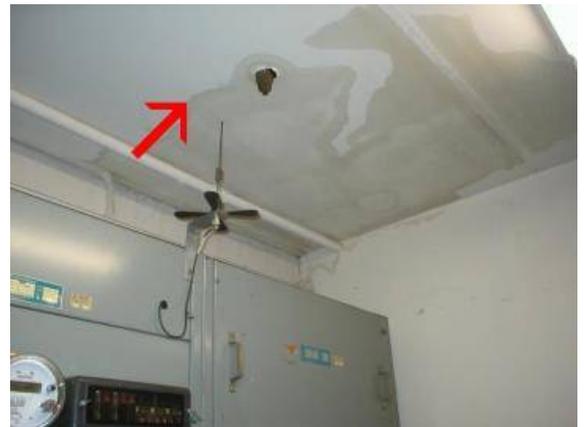
- 801 ROOMS INSPECTED All.
- 802 WALL(S)/CEILING(S) Materials: drywall. tile, suspended ceilings.
- 803 FLOOR(S) Materials: tile, vinyl, concrete.
- 806 COMMENTS [FE] [CR] Moisture stains and in some cases damage noted at the electrical room, ware house ceiling, Rm 7 & 26.

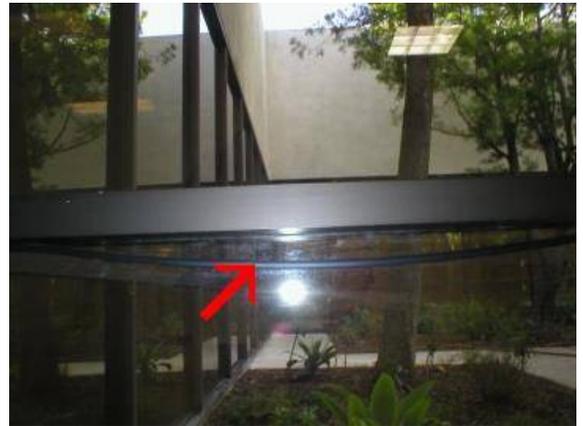
- 815 **INTERIOR DOOR(S)** The doors are functional with exceptions.
[CR] There is a roller shutter door in use in Rm 1. The door has a poor operation needs servicing/repair.
- 816 **EXTERIOR DOOR(S)** [FE] [CR] The warehouse roller shutter door and other exterior doors need service/repair for proper operation.
- 817 **WINDOW(S)** The accessible window(s) are functional, with exceptions.
[CR] Some deterioration of the window gaskets is noted at Rm 1.
