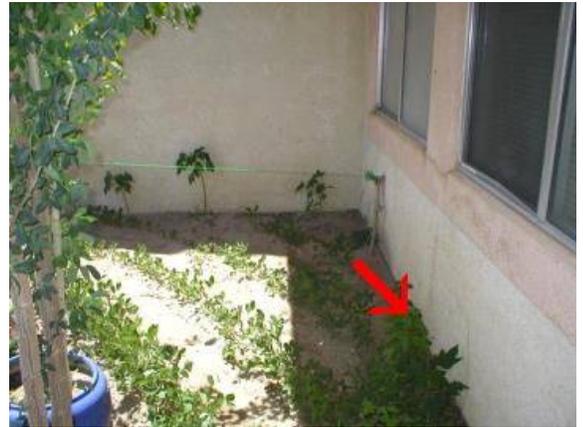
216 SITE GRADING

[CR] Present standards require a minimum of 6 inches clearance between the soil and any wood/metal construction. We recommend maintaining this clearance as much as is practical without creating a negative slope towards the structure. Some areas have less than 6 inches clearance to dirt.

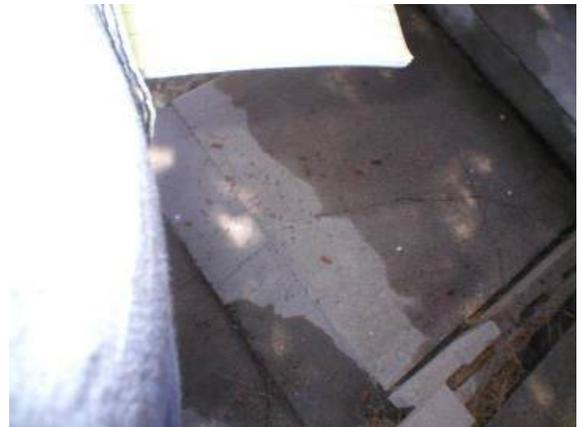
219 WALKWAY(S)

[SC] Uneven sections are noted in the walkway surface. This condition is a trip hazard.

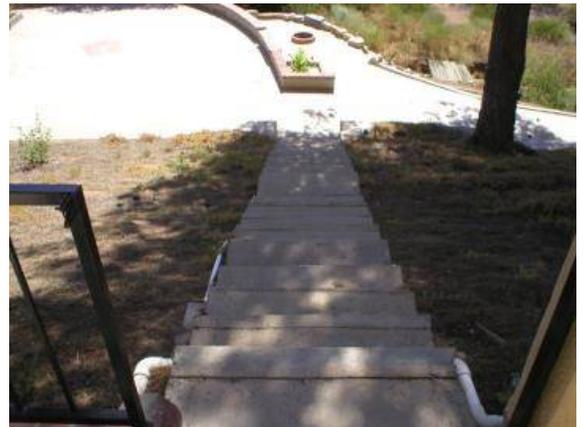
220 STEP(S)/STAIR(S)

[SC] There is improper height and inconsistent height on the risers on all of the steps on the property. This condition is a trip hazard.

[FE][CR] There are cracks in the tile surfaces at the balcony over the garages. We recommend correcting the condition(s) noted to prevent moisture intrusion into concealed spaces.

[SC] The bright sunlight does not allow the exterior painted concrete steps to be seen. This is a slip and fall hazard.

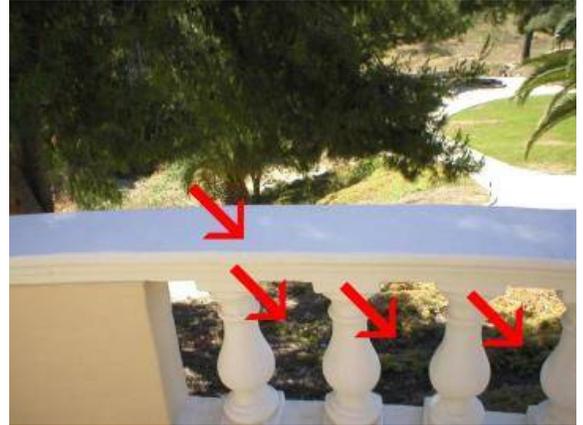
221 GUARDRAIL(S)

[SC] The front and right side concrete guardrail balustrades installed have wide spaces. We recommend additional measures be taken for child safety.

[SC] At the front and right side concrete guard rail wall the guard rails are too low, this is unsafe.

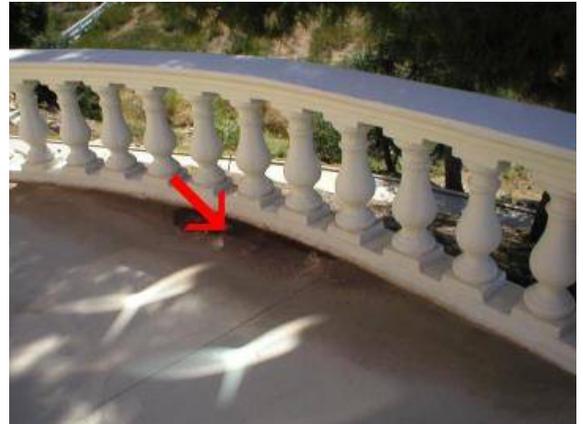
[SC] Evidence of ponding water is noted on the concrete patios. This condition is a slip and fall hazard.

[FE] [CR] There are cracks in the patio that have been painted over, these will return later.

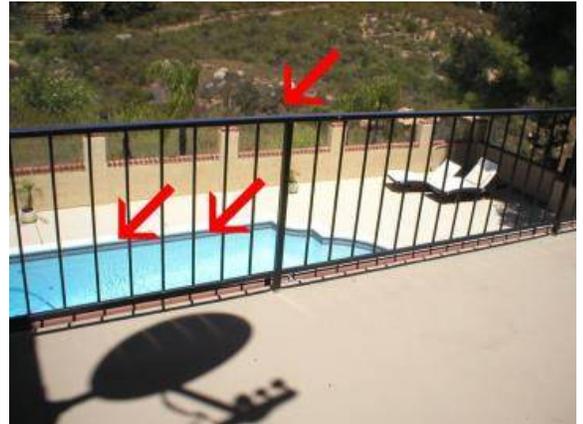
[SC] The guard railings are not high enough to provide adequate protection against falling and did not meet the present standards. Both.

[CR] Ponding water noted on the front bedroom planter balcony.

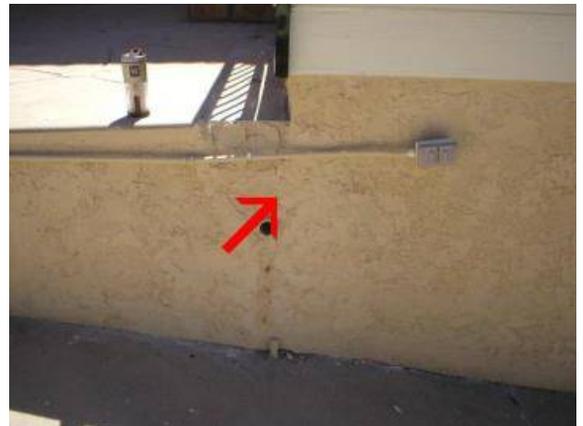
236 COMMENTS

[FE][CR] At the left rear of the garage balcony a separation has been stucco patched over at the rear of the garage wall.

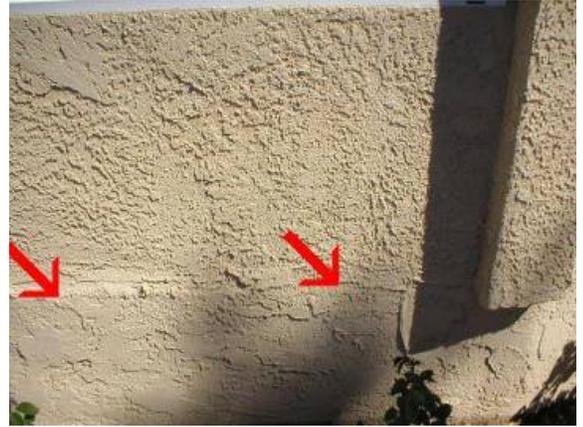
[FE] The stucco siding has recently been patched to cover over cracks. These cracks will reappear at a later date.

[CR] The weep screed is missing or has been patched over at the front right and rear walls. Pic.

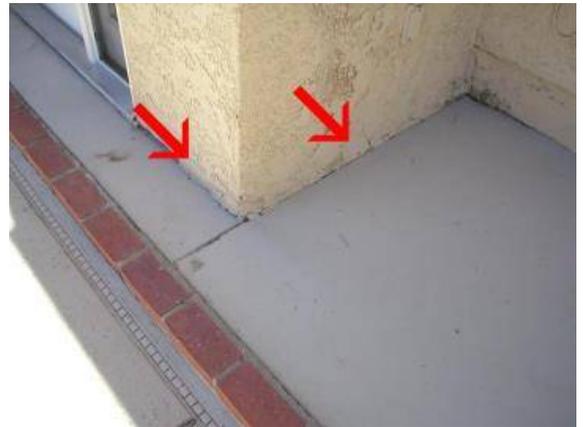
252 COMMENTS

[FE] [CR] The weep screed is buried or missing at the right rear room at the exterior.

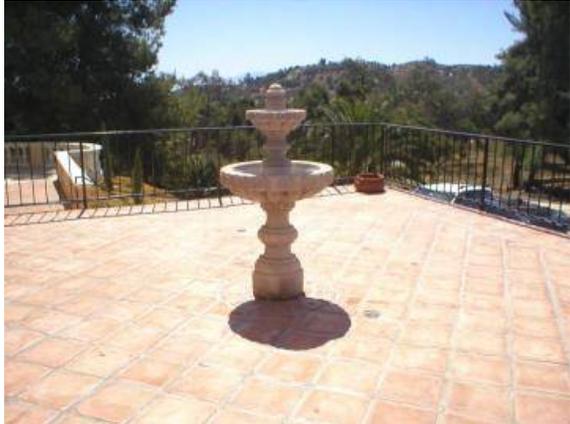
- [SC] [FE] Free-standing masonry fountains and statuary pose a topple hazard if not mechanically connected or secured. We recommend the fountains be mechanically connected and secured or removed for occupant and child safety. The front tiled balcony deck has an unsecured fountain present.

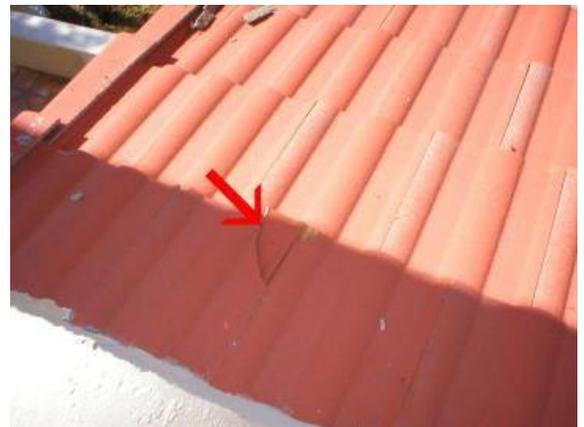
- 309 CONCRETE TILES** [CR] There are a number of cracked, broken and displaced tiles on the roof. The underlayment felt is exposed to the weather. There was loose weather blocking needing repair. These conditions are conducive to roof leaks.

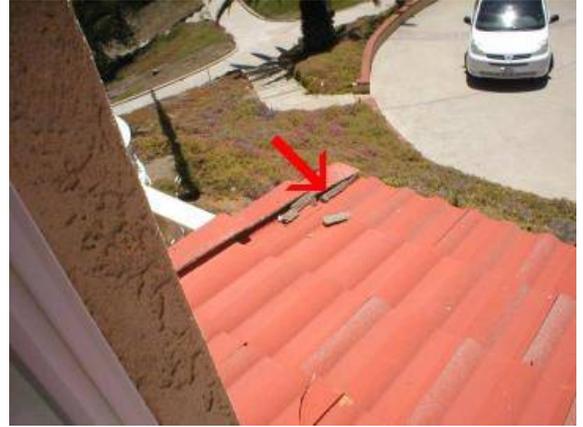
316 COMMENTS

[CR] There are a number of cracked, broken and displaced tiles on the roof. The underlayment felt is exposed to the weather. There was loose weather blocking needing repair. These conditions are conducive to roof leaks.

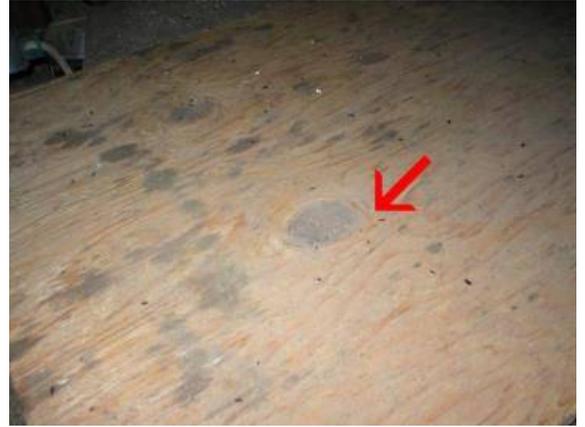
413 COMMENTS

[FE] Evidence of rodent activity is noted in the attic and under the stairs.

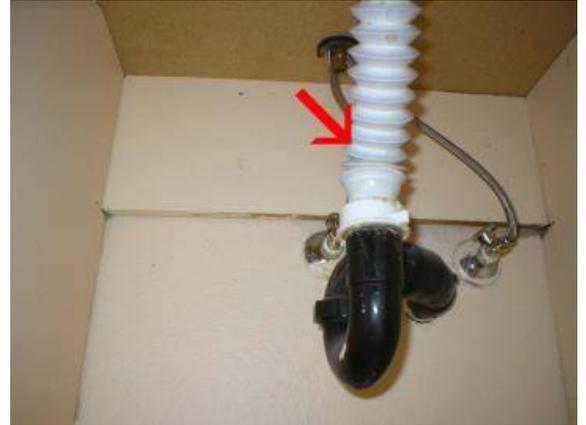
[SC] Corrugated plastic used as drain piping, this material is not approved for this application, the corrugations trap bacteria. Lower bath.

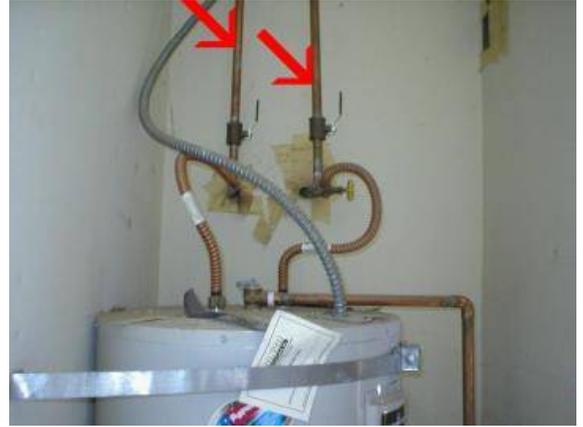
534 SUPPLY PIPING

[CR] The shutoff valve and observable water supply connectors are not insulated as required. We recommend insulating the exposed water piping to minimize heat loss.

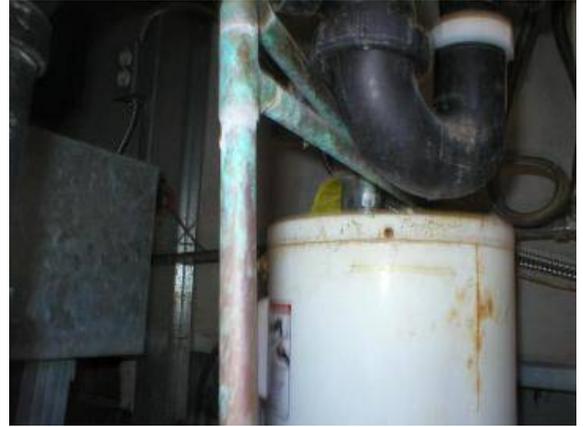
- 536 TANK(S) [FE] The metal casing of the water heater tank is corroded/deteriorated. The unit is unplugged and not tested.

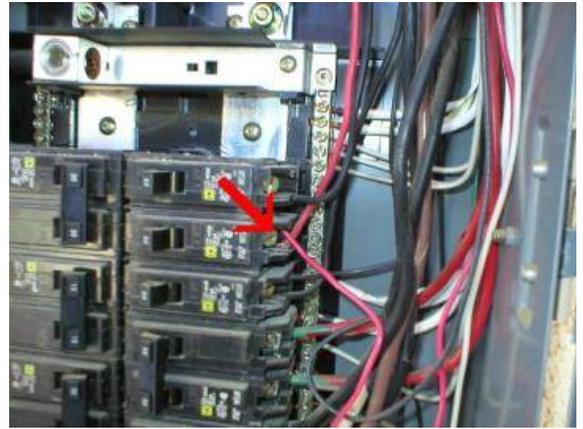
[SC] Holes in can/missing blank plugs noted.

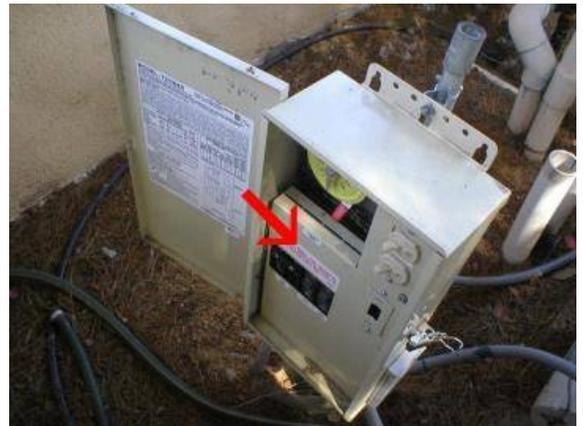
[SC] Inadequate clearance to the panel due to the masonry wall. We recommend to provide the required access to the panel for maintenance or emergency needs.

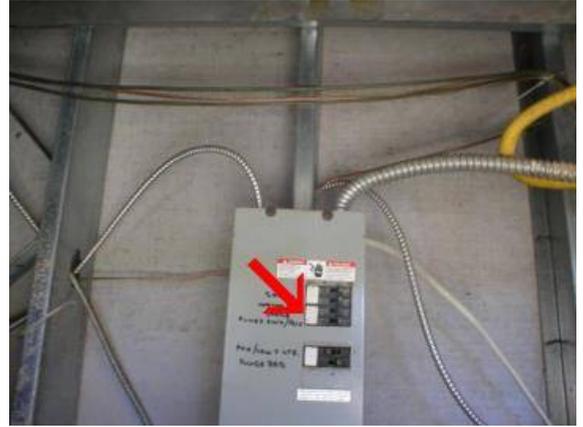
[SC] The panel is improperly installed in this location and not considered accessible.

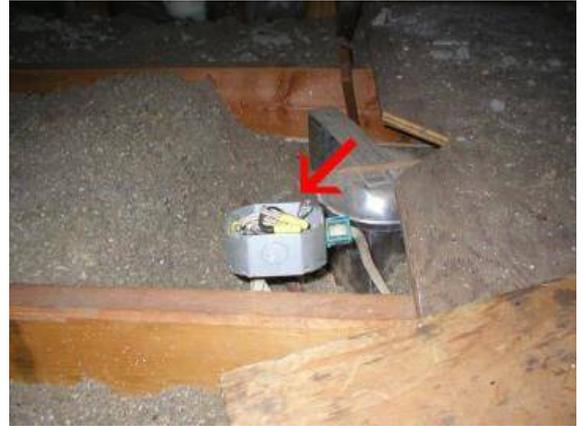
[SC] Improperly installed and exposed unprotected non metallic wiring is noted in the following locations: garage, pond areas, under the stairs, water heater closet.

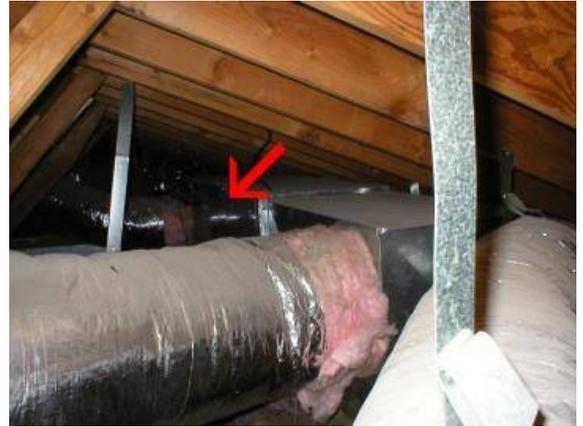
702 BRAND [FE] Unknown, the unit is not safely accessible. See below.

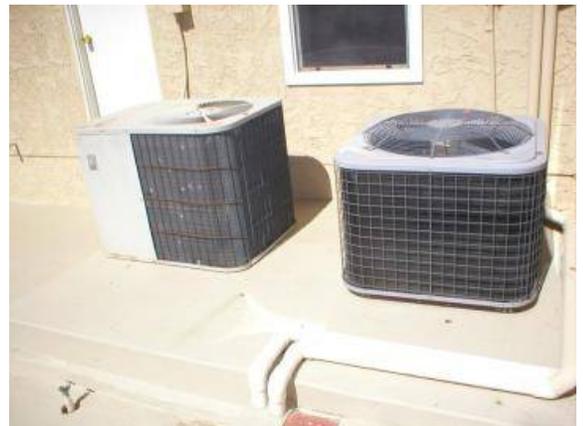
717 LOCATION(S) The unit [2] are located on the right side of the building.

718 BRAND manufactured in 1981 & International comfort manufactured in 2009.

720 SYSTEM TYPE(S) "Split system" The condensing unit and evaporator coils are at different locations.

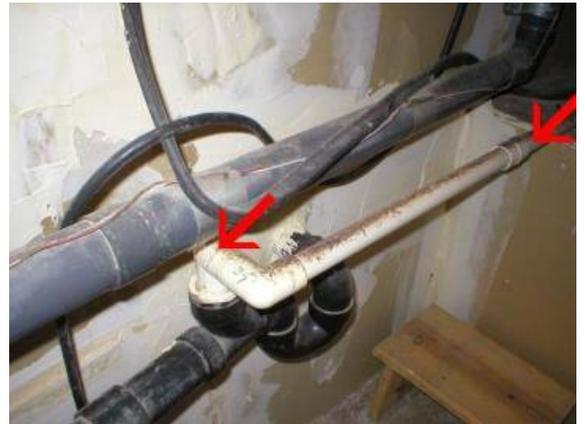
- 730 CONDENSATE DRAIN(S) The observable areas of the condensate drain lines and terminations appeared functional. In the attic
- [CR] The condensate drain line trap and vent are missing, this is required for proper operation and energy savings.
- [SC] The under stairs drain line dumps in a plumbing line with no air gap. This is unsafe.

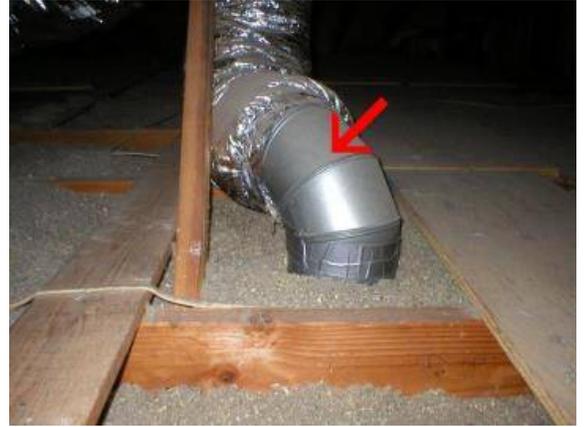
[CR] There are uninsulated ducts noted in the attic. Pic.

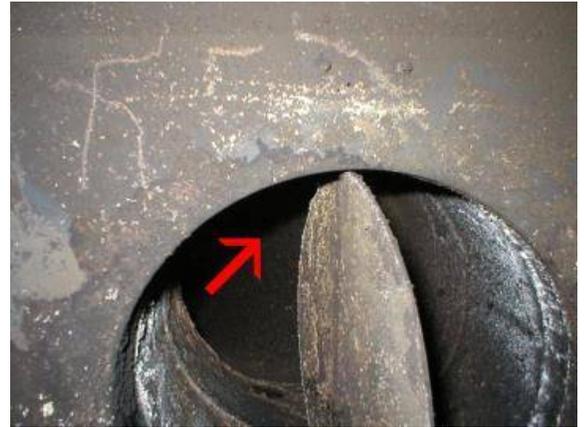
805 CHIMNEY(S)	The observable exterior areas of the chimney appeared functional.
806 SPARK ARRESTOR(S)	There is a spark arrester installed.
807 FIREBOX(S)	[RU] There are no glass doors present. We recommend adding doors as an energy upgrade.
808 DAMPERS	[SC] The observable areas of the flue is dirty needs to be cleaned.

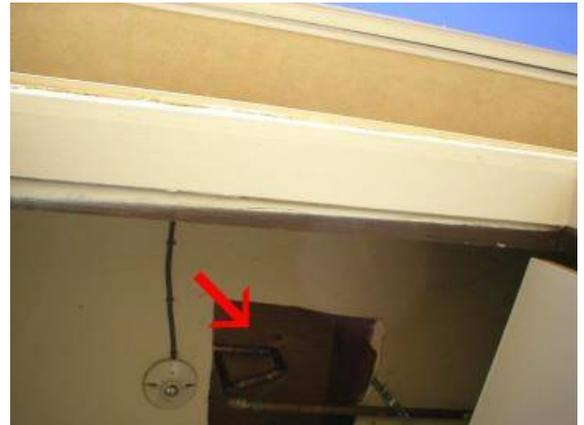
[CR] Holes in the water heater exterior right side closet need to be repaired.

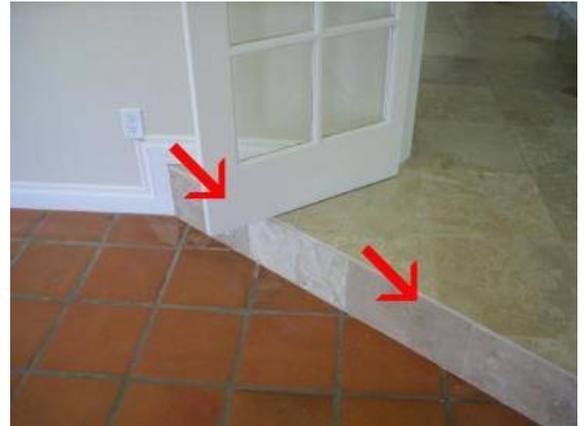
- 915 INTERIOR DOOR(S)** The doors are functional and latch, with exceptions noted.
[CR] The door rubbed. Laundry.
[SC] The doors swing out over a step down exceeding 1 1/2 of an inch. The landing area is too small at the lower right rear room. The step height exceeds the maximum allowed for steps. These conditions are safety hazards. Pic.

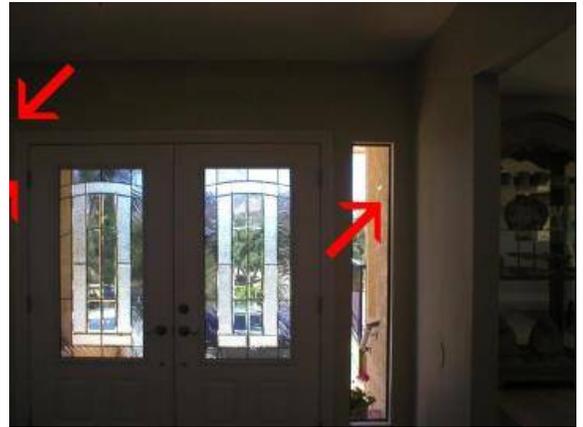
[SC] There are no observable safety glass markings on the glass where subject to human impact at the following locations; panes each side of the entry doors. The circular glass in the right side master bathroom.

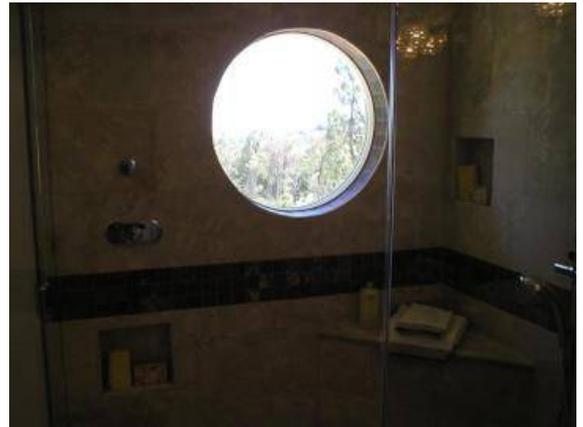
922 COMMENTS:

[SC] There are no observable safety glass markings on the glass where subject to human impact at the following locations; panes each side of the entry doors. The circular glass in the right side master bathroom.

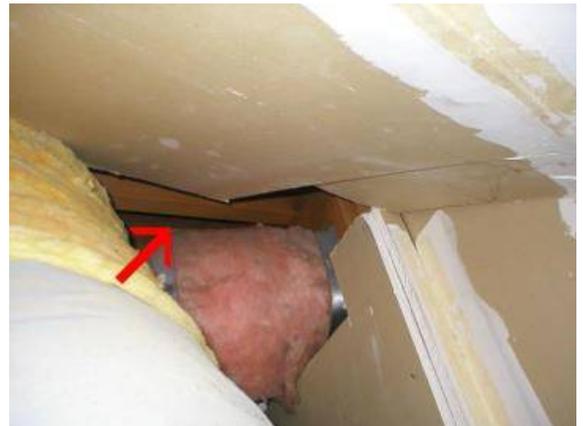
[SC] The area under the stairwell is in use for storage and a heat pump is located there. There is exposed wood framing, exposed wiring and plumbing pipes. This area is required to be a fully sealed fire wall to limit fire accessing the framing. We recommend correcting the conditions noted using approved methods for safety reasons.

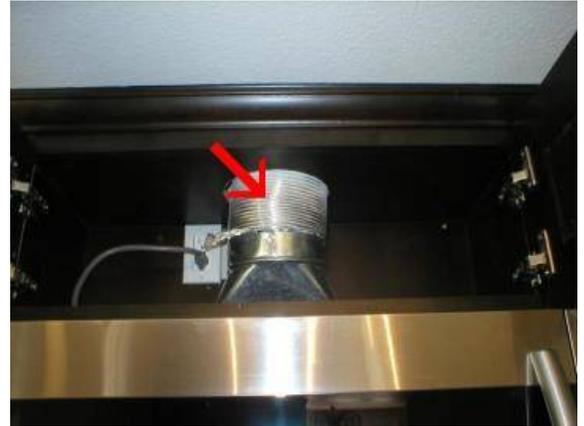
- 945 **EXHAUST VENT(S)** The exhaust fan/ luminaire [light] functioned.
- [SC] The observable portion of the exhaust vent ducting is a corrugated flexible material , these products are not approved for kitchen exhaust vents.

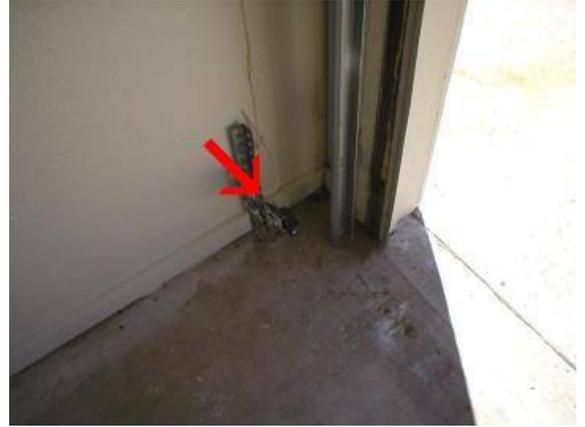
[SC] The automatic reversing systems are not installed on the door tracks as required, this is an unsafe configuration.

The automatic garage door openers are operational and the automatic reversing system functioned when the door hit a 1 inch object placed in its path on the ground while closing. The secondary safety system (electric eyes) functioned.

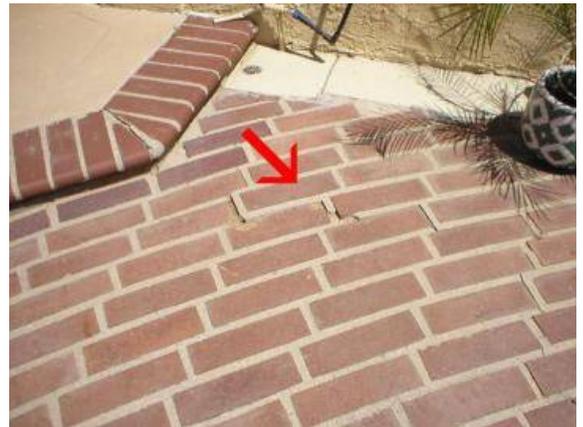
1009 DECKING	<p>[CR] Painted over cracks noted in the spa and pool decking.</p> <p>[FE] Settlement noted to the pool and spa decking and masonry walls.</p> <p>[SC] Uneven lifted sections were noted in the pool decking surface. This condition is a trip hazard. Pic.</p>
---------------------	---

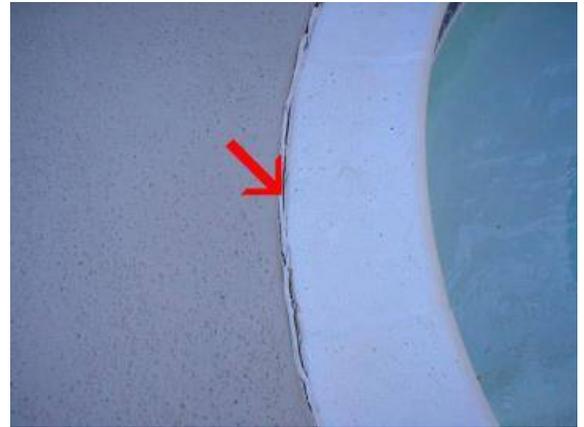
[CR] The caulking between the coping and pool/spa deck surface was cracked/damaged and missing. This condition is conducive to moisture intrusion and lifting decks.

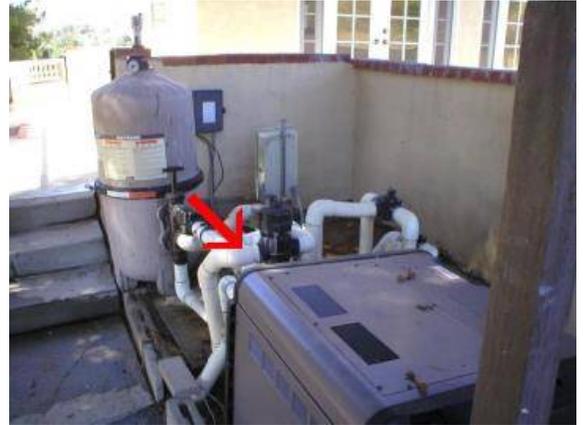
[CR] Sections of the PVC piping were not painted to protect them from the sun's ultraviolet rays.
